ASSESSMENT OF THE ENVIRONMENTAL CONDITIONS OF THE ELEMENTS OF A RURAL LANDSCAPE USING THE FREE SOFTWARE GOOGLE EARTH PRO

ABSTRACT

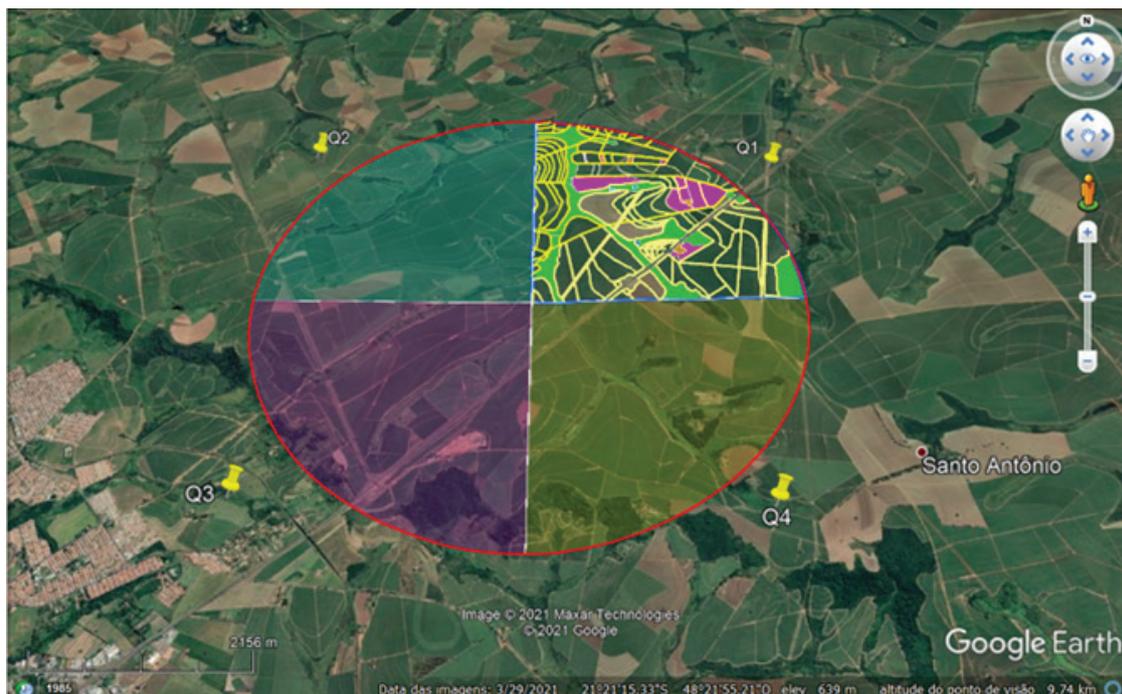
Figure 1. Sample area of the uppermost region of the Taquaritinga watershed, SP.
Source: Google Earth Pro (March 2021); Q1, Q2, Q3, and Q4: Quadrants of the sample area of 3581 ha.

The study was carried out in the region of latitude 21°22′12.94 “S and longitude 48°26′29.97 “W of the highest region of the Taquaritinga watershed, which belongs to the Tietê-Batalha Watershed Council (CBH-TB). For the study, a sample area of approximately 3581 ha was designated (**Figure 1**), made with the “line” tool in the “circle” tab of the free software Google Earth Pro (2021). From this sample area of 3581 ha, it was divided into four quadrants using the Google Earth Pro tools, according to Rodrigues, Bovério, and Ferrarezi (2020). **Figure 1** shows the main study area and the elements of Quadrant 1 in colored highlights.

The elements of the rural landscape, which are the sugarcane carriers (SC), impermeable area (IA)—represented by the asphalt grid—, area of permanent preservation (APP), construction areas (CA), woody crop areas (WC), and water table areas (WT), were quantified in the four quadrants using the “polygon” tool, which includes information on the perimeter and area of each element in each quadrant. The

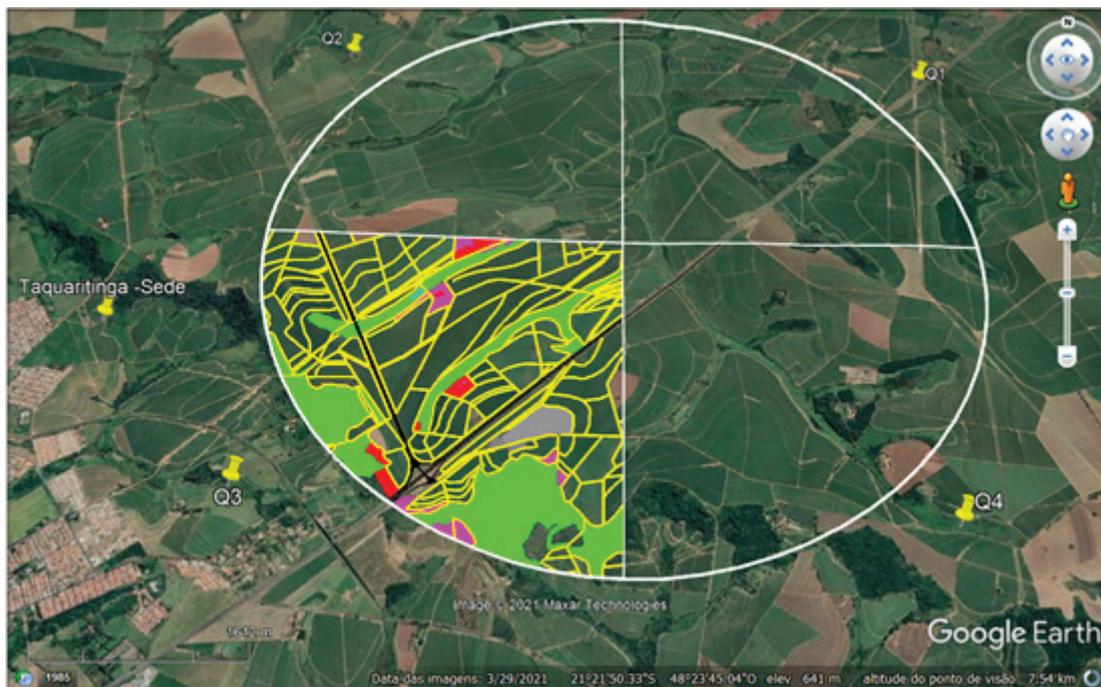
Figure 2. Sample area of the uppermost region of the Taquaritinga watershed, SP (Quadrant 3), highlighting the main landscape elements: Areas of Permanent Preservation (APP, light green), Areas of Woody Crops (pink), Areas of Rural Construction (red), Carriers (yellow), Institutional Area (gray), Impervious Area (black), and Areas of Sugarcane Cultivation (dark green).

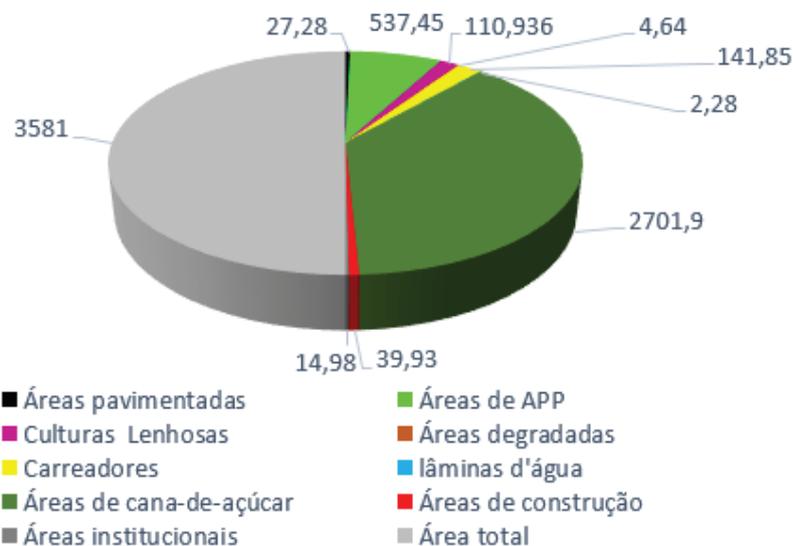
Graph 1. Rural landscape elements in the uppermost region of the Taquaritinga Watershed

Gráfico 1. Elementos da paisagem rural na região mais alta da Bacia hidrográfica de Taquaritinga

showed that there was a significant difference ($P < 0.11$) only regarding the size of the sugarcane fields. The quantification results of the rural landscape elements that are possible to quantify or visually identify are shown in **Graph 1**. The four most expressive elements in the landscape correspond to the sugarcane crop (75%), followed by Areas of Permanent Preservation (APP = 15.1%), Woody Crops (3.1%), Carriers (CA = 3.96%), Construction Areas (CA = 1.12%), Paved Areas (impermeable) (PA = 0.76%), Institutional Areas (IA = 0.42%), and Water Blades (0.06%), for a total of 3581 ha. Since the total area of this study corresponds to 3581 ha, according to the new Forest Code, the areas destined for the Legal Reserve (LR) should correspond to approximately 20% of the quadrant area, i.e., 716.2 ha.

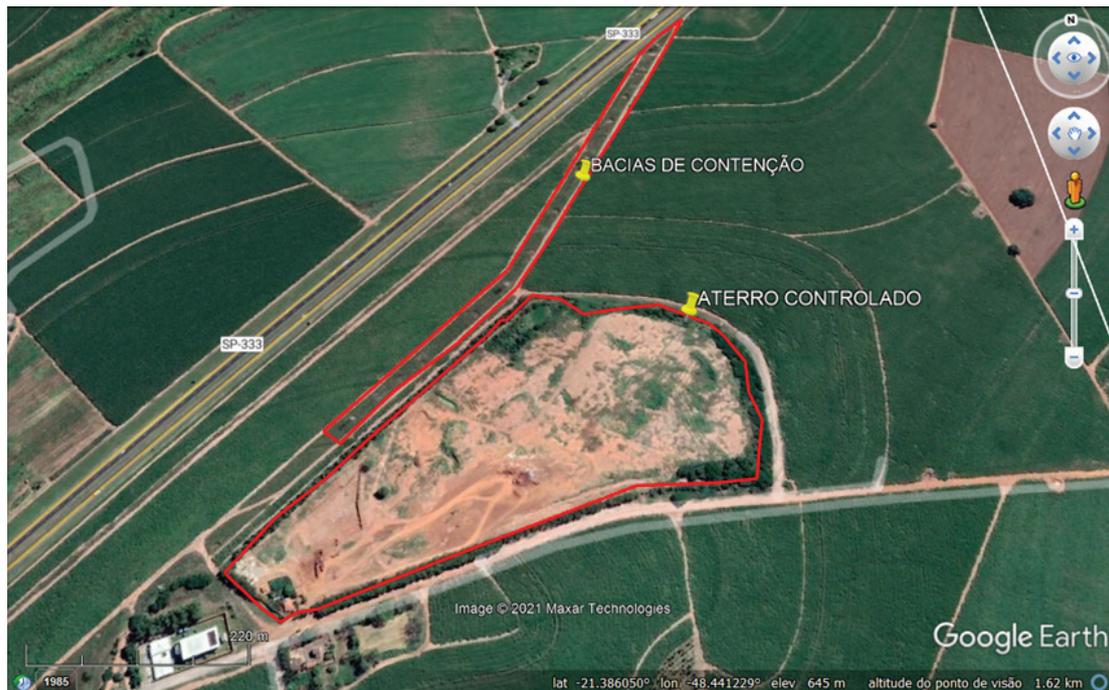
Figure 3. The highlight of the main landscape elements in quadrant 3 (larger red outline) represents the controlled landfill in Taquaritinga, SP. In a smaller red outline are the stormwater containment basins.

Legend: Containment Basins; Controlled Landfill.
Source: Google Earth Pro (May 2021)

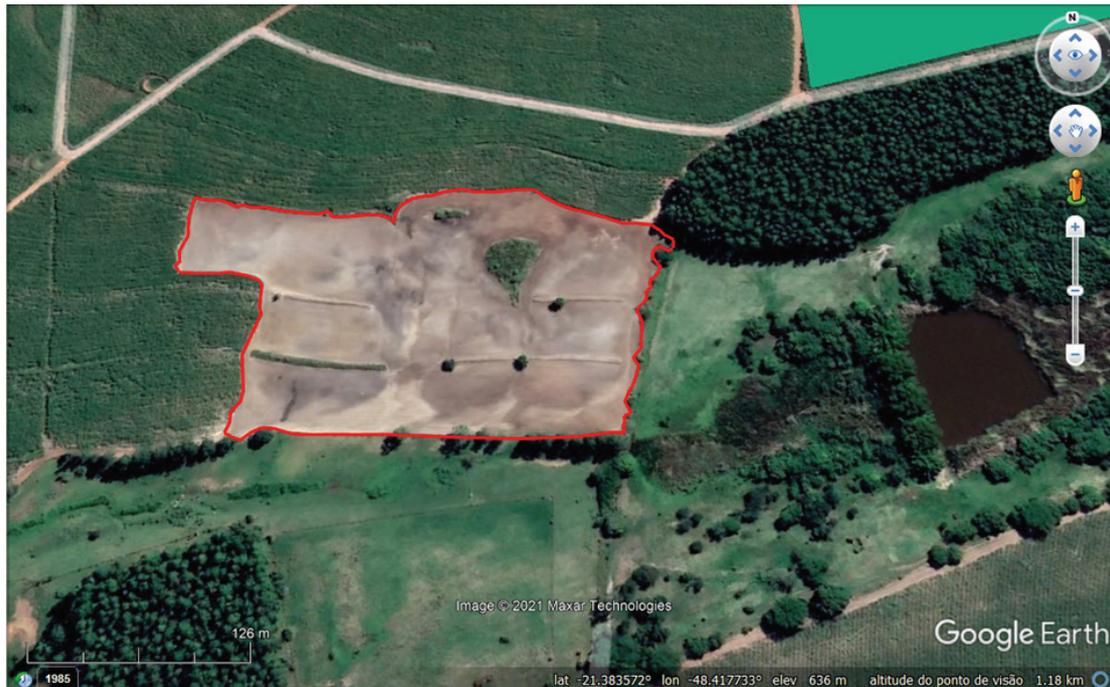
Figure 4. The highlighted landscape element in quadrant 4 (red outline) represents a single degraded area in the sample.
Source: Google Earth Pro (May 2021)
