THE IMPORTANCE OF ASSESSING OCCUPATIONAL RISKS AND FACTORS THAT COMPROMISE ENVIRONMENTAL COMFORT FOR STUDENTS AND PROFESSIONALS IN THE SCHOOL ENVIRONMENT

The knowledge integration encompassed by occupational safety and its analysis methods has been increasingly used in many different types of organizations. This is due to the importance of obtaining a healthy and safe environment for the collaborator. The current work was carried out in a municipal public school in Presidente Prudente, São Paulo (SP), which serves kindergarten and elementary schools. As an objective, suggestions for improving the work environment are proposed, aiming to provide more comfort and satisfaction with it, in addition to identifying and evaluating the occupational risks to which students and workers in the environment are exposed. To this end, a survey of environmental risks was conducted within the existing risk classifications, and for this, the Preliminary Risk Analysis (PRA) method and the relevance matrix were used. Moreover, issues related to environmental comfort were also verified, analyzing the temperature of the environment and its lighting at strategic points, and comparing them with the value

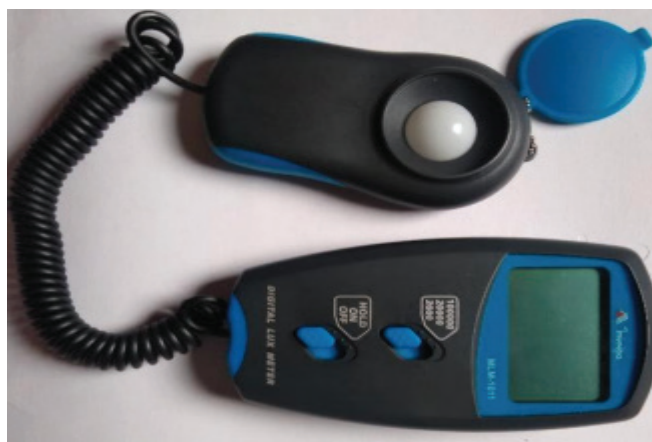
Figure 2. lux meter
Source: The authors (2022)

For the luminosity verifications, we used the NHO-11 guidelines, the recommendation for the choice of measuring points for the due calculations, and the parameter values presented in the ABNT NBR ISO/CIE 8995-1 standard, which deals with the verification of indoor lighting (Equation 1). For these measurements, we used a Minipa lux meter, model MLM-1011 (Figure 2), and the illuminance calculation for indoor work environments established by the Occupational Hygiene Standard (NHO) 11 (2018).

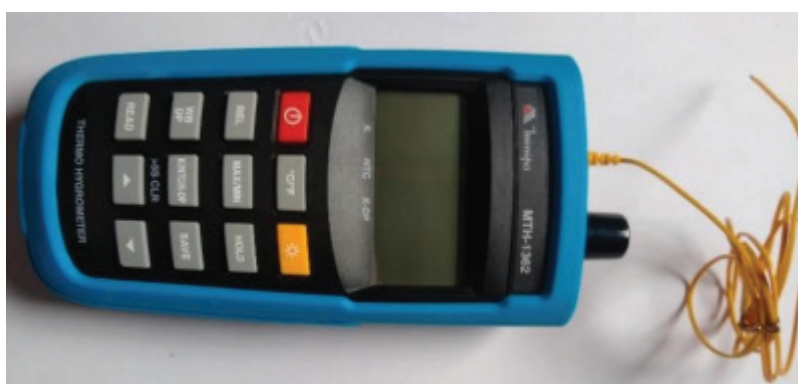
Figure 3. digital thermo-hygrometer
Source: The authors (2022)

Regarding collecting temperature data from the chosen environments, we used a Minipa digital thermo-hygrometer, model MTH-1362 (Figure 3). Data collection occurred at specific points chosen according to the spaces where the professionals involved in each environment develop their activities since the standard needs to be more specific about determining measuring points.

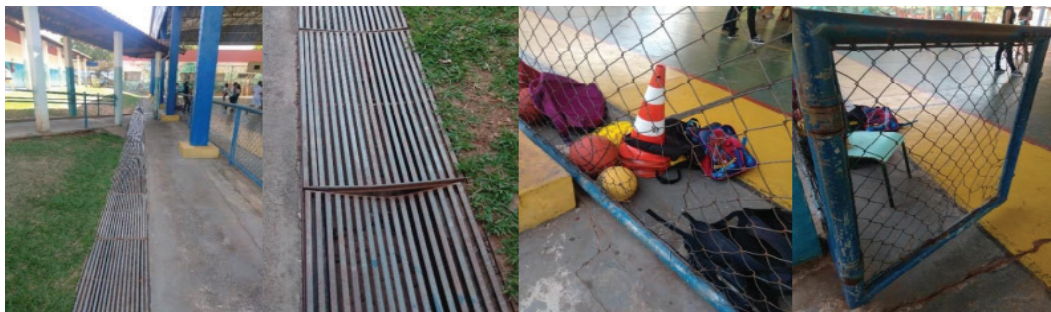
Figure 4. Riscos encontrados na área externa

In addition, it was observed that the entire area around the school court has iron grids for water drainage (**Figure 4**), but many of these grids have problems caused by the weather. Many incidents have been reported with employees and students who have tripped, fallen, and injured themselves on these deformities, as it is a passage to enter the court.

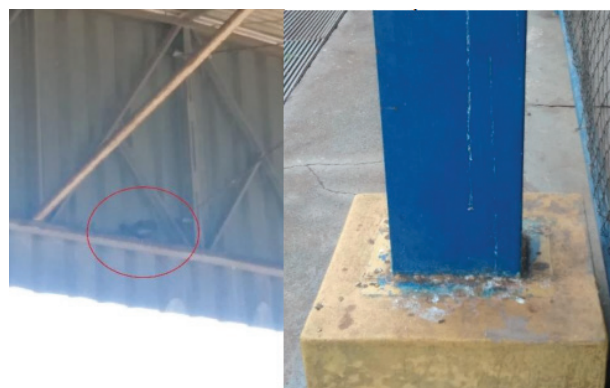
Figure 5. Presence of urban pigeons

Another problem found in the external area relates to the presence of urban pigeons (**Figure 5**) that make their nests on the roof of the court and whose feces dirty several spots that need cleaning almost daily.

It is worth noting that pigeon droppings cause various issues, the most serious of which is the presence of pathogenic microorganisms and parasites in these birds' excrement. It is important to remember that these droppings can cause diseases and that human infection can occur through the respiratory system (Sarmiento *et al.*, 2019).

The unit's management reported that the municipality recently contracted a company to control pigeon infestations in municipal schools; moreover, the alternatives implemented by the contracted company still need to put an end to the infestation. Initially, sound systems were installed to keep the pigeons away, and later, the pigeon-repellent gel was used on all the roofing hardware. Neither measure was efficient, leaving this problem unsolved until the present moment.

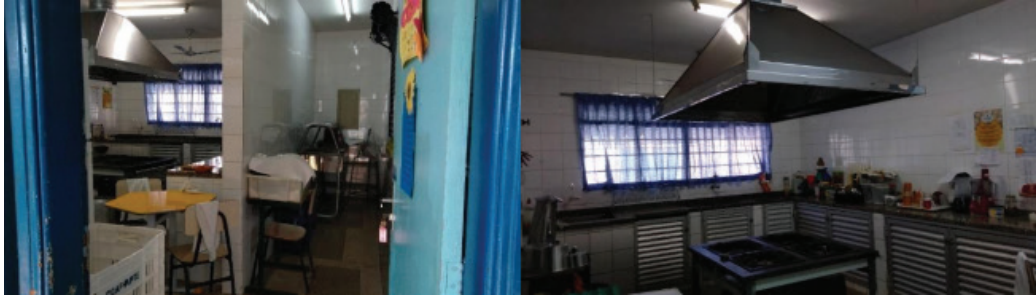
Figure 6. kitchen analysis

Great visual pollution was noticed in the kitchen, with many objects scattered around due to a lack of space. A wall divides the kitchen and the access counters for serving meals, but they are not used for this purpose because the meals are served in the thermal cart or on a table in the cafeteria so that students can serve themselves independently.

Poor lighting was identified because one of the lamps is above the exhaust hood, blocking the lighting in much of the same working space as the cooks. There they would need good lighting for the good progress of the activities and the reduction of visual fatigue during service hours (**Figure 6**). The PRA performed in the kitchen is detailed in **Chart 2**, where the various existing risks are grouped according to the NR 9 risk classification.

For improvements in the kitchen, we highlight the points related to lighting and temperature, which could be alleviated through the repair of the industrial hood - urgently - given that the city has as its main characteristic high temperatures. Consequently, the kitchen environment becomes hotter, so the good functioning of the exhaust hood for heat removal becomes primordial.

Still, it is recommended that the kitchen be reformulated and adapted so that activities can be performed more comfortably because the structure does not allow for easy circulation of external ventilation, making the environment even hotter.

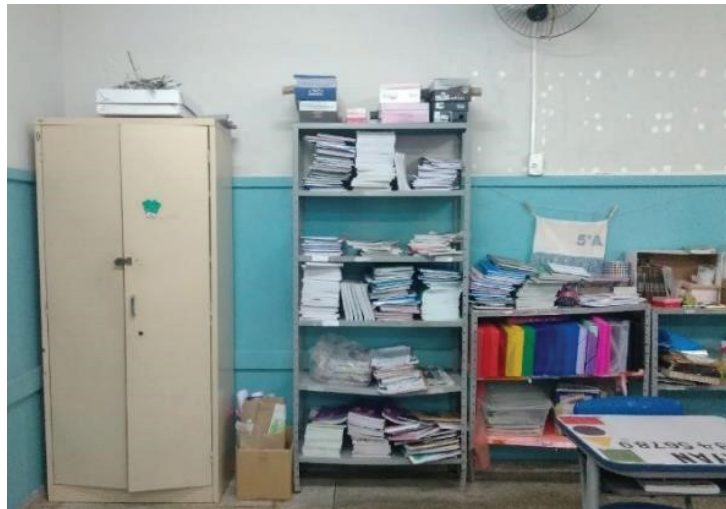
Figure 7. Disorganized materials and old cabinets

There is also the problem of cabinets storing various materials and toys used by the children. Some of these cabinets are old and at risk of falling and accumulating materials (**Figure 7**).

Objects dropping from high places	Old closets with many toys piled up	Wounds, injuries	Accidents	4	3	12	Built-in closets on the lowest level
Poor lighting	Burnt-out light bulbs and other low-power bulbs	Visual fatigue, stress, inattention	Accidents	4	2	8	Adjustment of light bulbs and use of natural light
Bites and injuries caused by animals	The presence of insects and poisonous and wild animals	Allergic reaction, stings, bruises	Accidents	4	3	12	Dedication, building a barrier around the unit

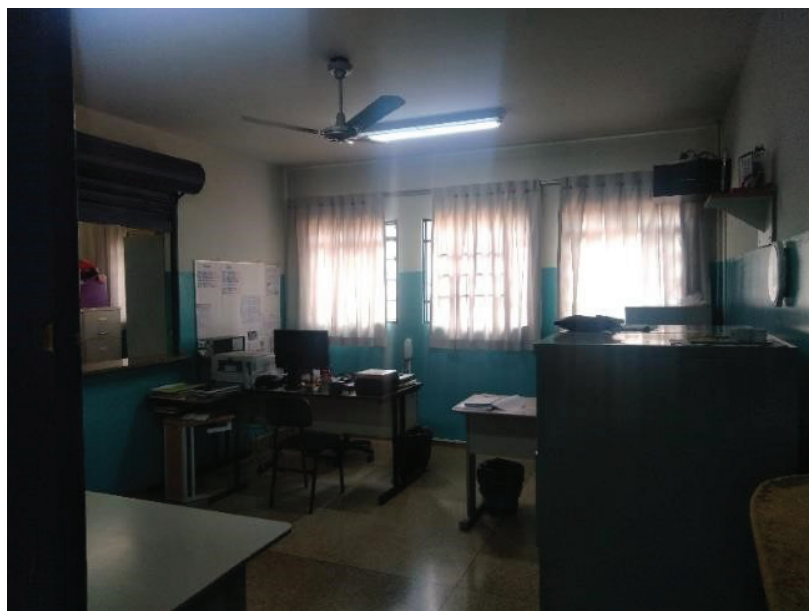
Figure 8. Secretariat
Source: The authors (2022)

In this place, we saw that the lighting was deficient. The employee's work is almost entirely performed by the computer, whose screen faces the luminosity coming from the window, reflecting on the screen in a way that, according

to the clerk, causes visual fatigue and stress (**Figure 8**). The office's PRA can be seen in **Chart 4**.

Poor lighting	Few bulbs	Visual fatigue, stress, inattention	Accidents	4	2	8	Adaptation of the lamps to artificial lighting or use of natural light allied to the layout adequacy

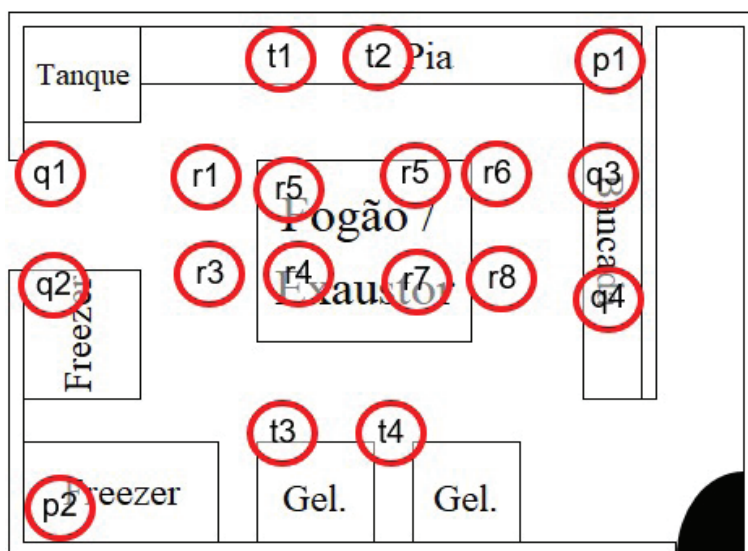
Figure 9. Points analyzed in the kitchen

Figure 9 shows the collection points instructed by NHO-11. The data were collected in the kitchen on four consecutive mornings between 8 a.m. and 11 a.m.

According to standard NHO-11 (2018), it is recommended that the illuminance measured point by point in the areas where tasks are performed should be at least 70% of the average illuminance. Therefore, considering the result obtained, 70% of (*I*) is equivalent to 149.57 lux, i.e., none of the points measured had a value equal to or lower than this.

The standard NBR ISO/CIE 8995-1: 2013 recommends that the illuminance values for environments such as the kitchen should be 500 lux. Thus, the necessary changes should be made to improve the brightness level, offering comfort and safety to the cooks working in that space and increasing satisfaction and productivity.

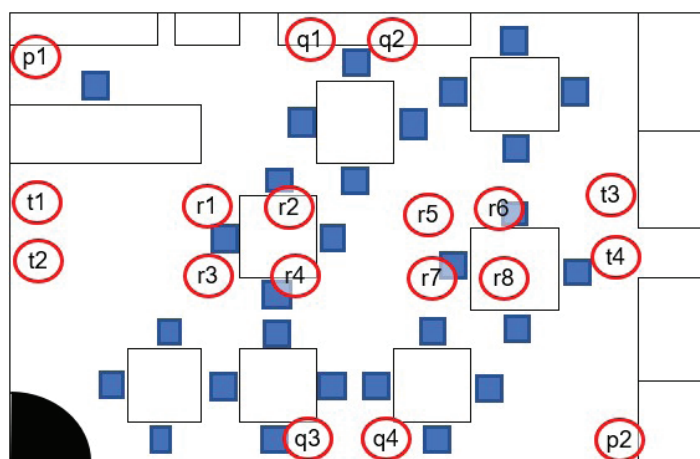
Figure 10. Light measurement points: Kindergarten room

However, even if the point-to-point measurement values are compatible with the allowed average illuminance, the standard NBR ISO/CIE 8995-1: 2013 recommends that the illuminance values for classrooms should be 300 lux for primary and secondary schools and 500 lux for evening classes and adult education. Thus, interventions should be carried out to improve the brightness level, providing environmental comfort for developing teachers' and students' activities in the classroom.

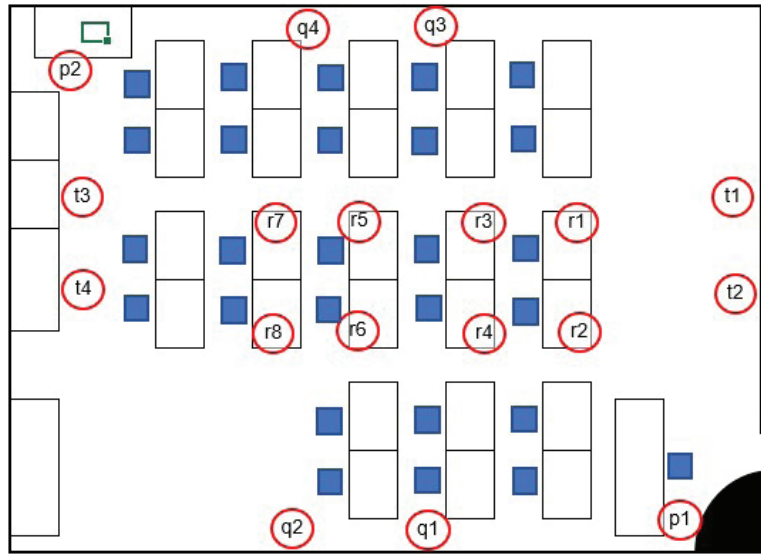
Figure 11. Brightness Gauging Points: Elementary school room

At this point, the resulting value of (*I*) was 310.69 lux. According to the normative recommendation NHO-11, the illuminance measured point by point in the areas where tasks are performed should not be less than 217.48 lux, i.e., the points t3 and t4 measured had lower values than the average illuminance (*I*) found.

As for the value of the average illuminance found in the elementary school room analyzed, it was found to be under the recommendation of the Standard NBR ISO/CIE 8995-1: 2013 on the brightness parameter of 300 lux for classrooms.

It is worth noting that the specific values below the allowed are located at the back of the classroom, where the shelves with materials and fluorescent bulbs do not have the same intensity of white light as the others that the LED model already has replaced are located.

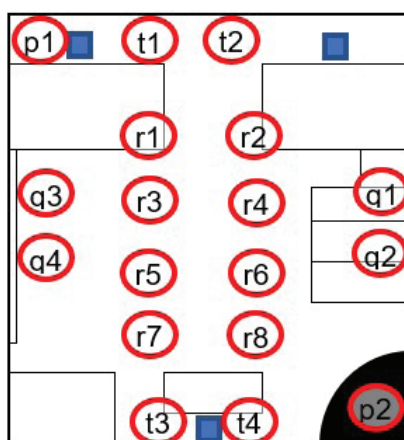
Figure 12. Brightness Gauging Points: secretariat

The secretariat's calculation (*I*) was 162.72 lux. According to the normative recommendation NHO-11, the illuminance measured point to point in the areas of task execution should not be less than 113.9 lux, so the point p2 presented in its average of measurements has a value lower than allowed according to the standard.

Regarding the average illuminance value found in the secretariat, it was found not to comply with the recommendation of Standard NBR ISO/CIE 8995-1:2013 nor with Standard NHO-11 on the luminosity parameter of 300 lux for offices and reception for public attendance.

It can also be observed that all the points measured near the walls, except for the walls with the windows, obtained lower values due to the bulbs' location since they are located in the central area of the office, even though these bulbs are LEDs with higher white light intensity.

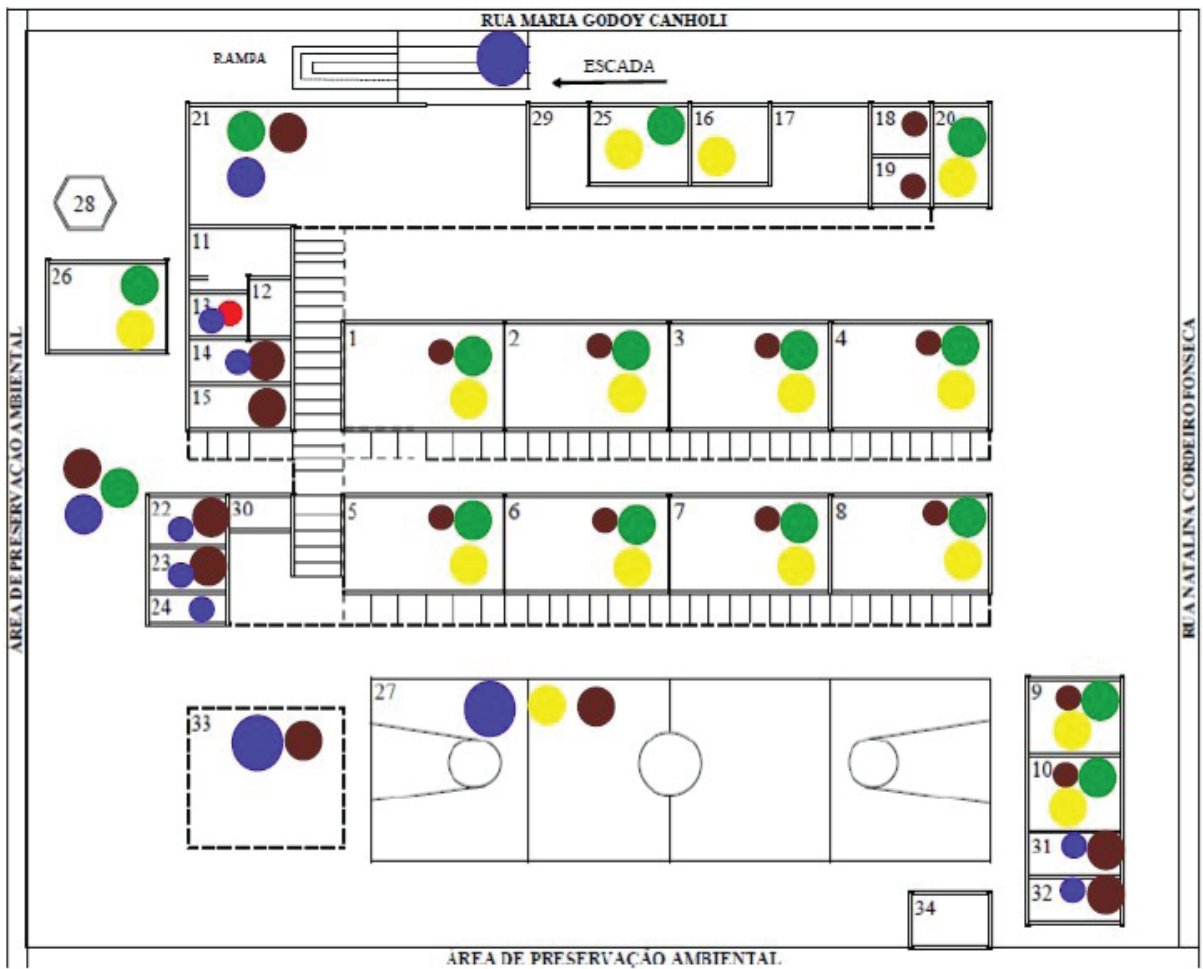
Figure 13. Risk map of the study area

With the survey of the previous information and the data obtained, it was possible to draw up a risk map of the site and, ultimately, provide proposals for preventive and control measures to minimize the risks found and avoid possible accidents arising from these risks.

It is noteworthy that the possibility of certain accidents was considered for the size definition of the circles represented in the risk map. In case of confirmation, the severity would be calculated, i.e., the level of consequence for the individuals suffering the accident. Regarding the colors, we used the standard recognized by NR: blue, mechanical risk;

yellow, ergonomic risk; green, physical risk; and brown, biological risk (NR 15, 2011).
